Structural Integrity Reserve Study

Project # 23RL-1178
April 2, 2025

***Starlight Towers Condominium
SIRS Report***

***6000 North Ocean Boulevard,
Lauderdale-By-The-Sea,
FL 33308***

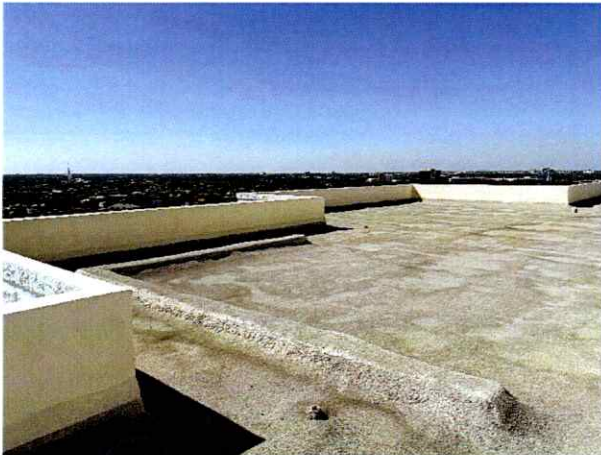
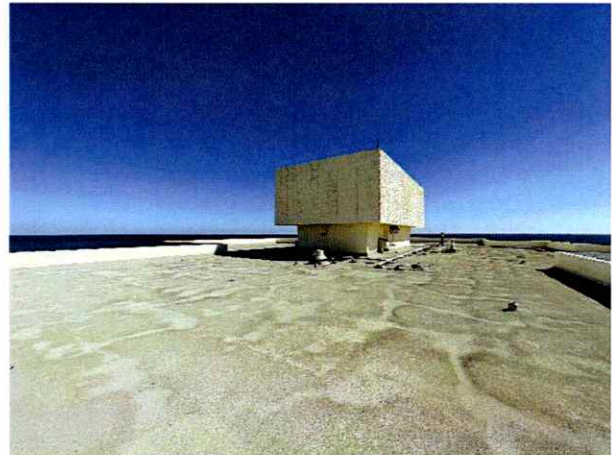
- Component Condition: Fair.
- Commentary: The structure has a flat re-roof with a bitumen membrane surrounded by CMU parapet walls. The upper roof includes two primary structures: the mechanical tower and the elevator machine room. There are exposed pipes running along the roof surface, which appear securely fastened.
- Recommendations: KEG recommends installing a new roofing.

Figure 1: Roof Level Actual Condition

Figure 2: Roof Level Actual Condition.

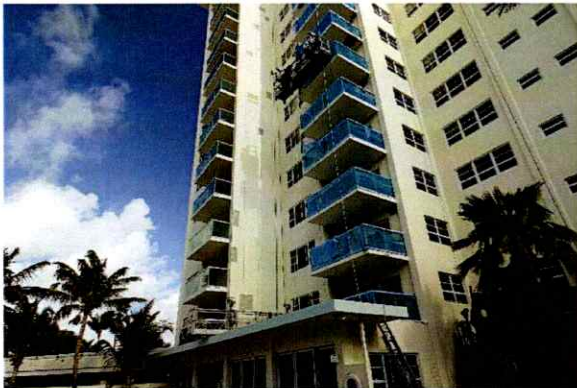
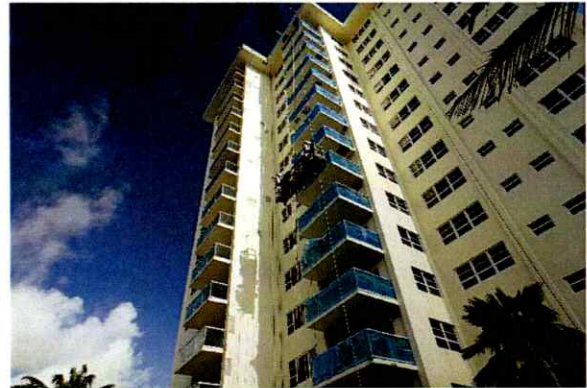
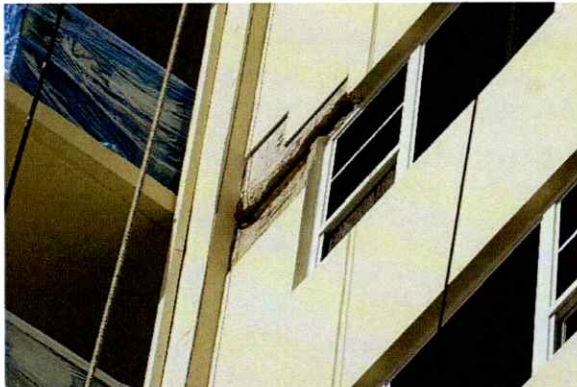
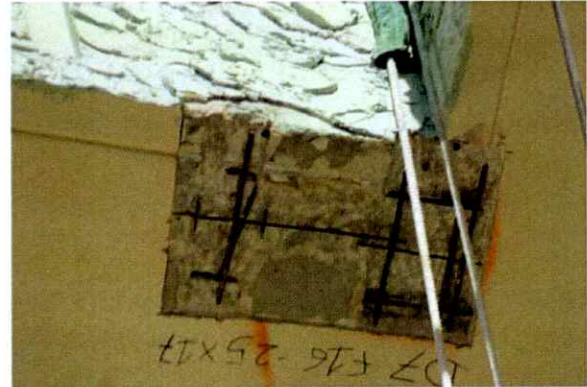
- Component Condition: Fair.
- Commentary: Starlight Towers Association hired Suncoast Painting and Professional Services, Inc. to perform a waterproofing, painting, and building restoration project. All visible deficiencies are currently being addressed in balconies/walkways and building façade. KEG as the Engineer of Record (EOR) has been performing the inspections during the course of the project to ensure the correct completion of the repairs mentioned.
- Recommendations: After the completion of the restoration project, the association is to implement proper maintenance protocol of the areas addressed by the restoration project to prolong the longevity of the structure.

Figure 3: Repairs in Progress

Figure 4: Repairs in Progress

Figure 5: Repairs in Progress

Figure 6: Repairs in Progress

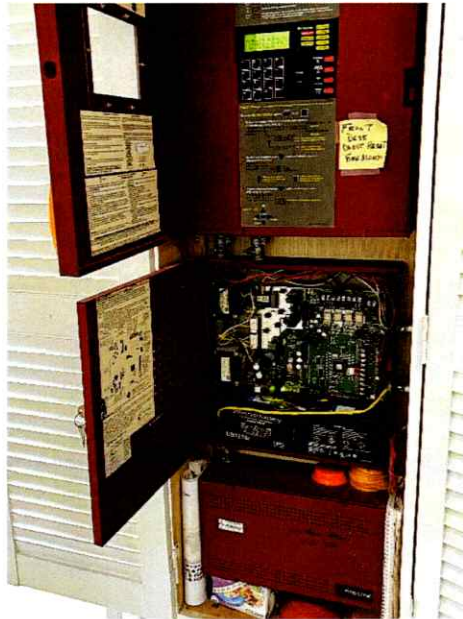
- Component Condition: Good
- Commentary: The observed elements of the fire protection system, including the fire alarm control panel (FACP), fire pump, and sprinkler system, were found to be in adequate condition. While the system is operational, routine maintenance and testing are required to ensure continued reliability. The estimated remaining life varies for different components; however, all elements should be maintained as necessary to maximize their useful life.
- Recommendations: Regular maintenance in accordance with the jurisdiction authorities.

Figure 7: Fire Alarm Panel

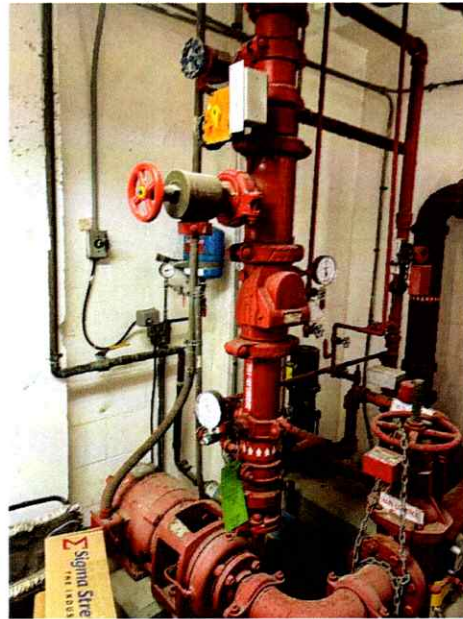
Figure 8: Fire Sprinkler System

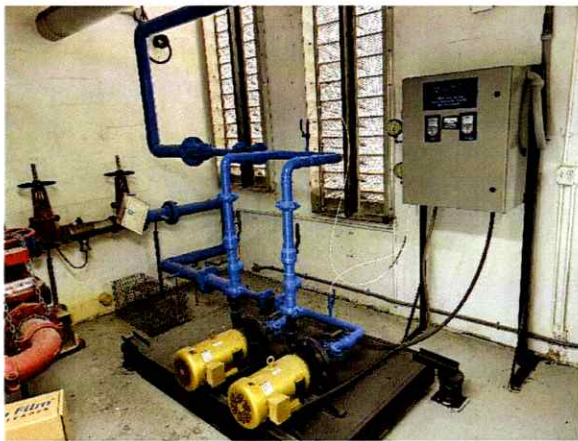
- Component Condition: Good.
- Commentary: The observed elements of the plumbing system were in adequate condition. The water distribution lines, fixtures, and drainage components are generally well-maintained. Although the useful appearance observed on some piping joints and fittings, the overall system performance remains within acceptable standards. The estimated remaining life varies among components; however, routine maintenance and timely repairs will help extend the useful life of the entire system.
- Recommendations: Continued maintenance and repairs necessary will help sustain the plumbing system’s performance and extend its service life.

Figure 9: Existing Water Valves Installed

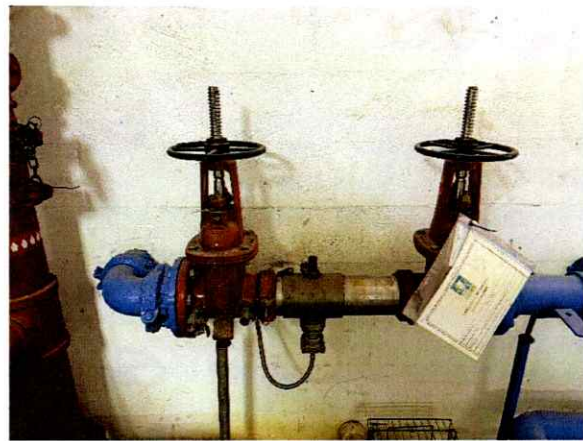
Figure 10: Main Valve of Starligh Towers

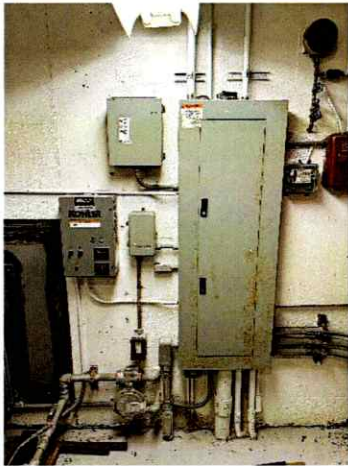
- Component Condition: Fair
- Commentary: The observed elements of the electrical system, including the main electrical panels, generator transfer switch, and associated distribution components, were found to be in fair condition. The system appears to be functional with clear labeling on circuit breakers and equipment. However, surface rust and signs of aging are present on some panels and enclosures, which should be monitored and treated to prolong the remaining useful life.
- Recommendations: Continued maintenance as necessary.

Figure 11: Main Breaker Panel

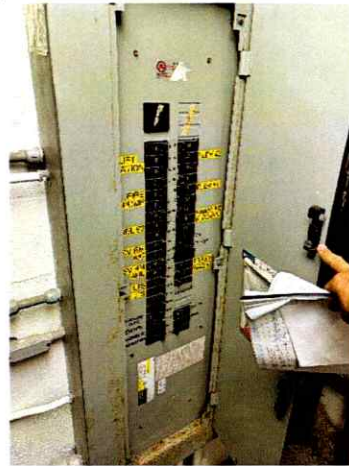
Figure 12: Main Breaker Panels

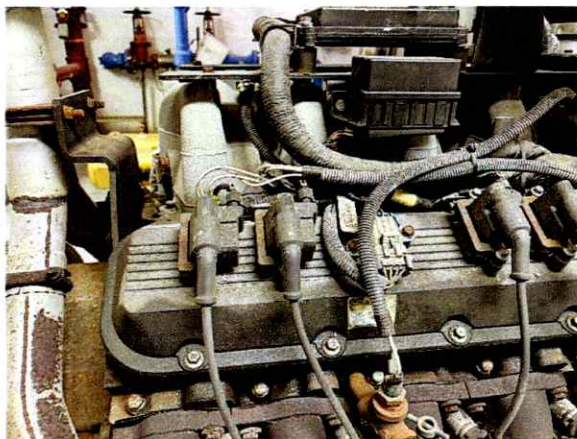
Figure 13: Condition of the Generator

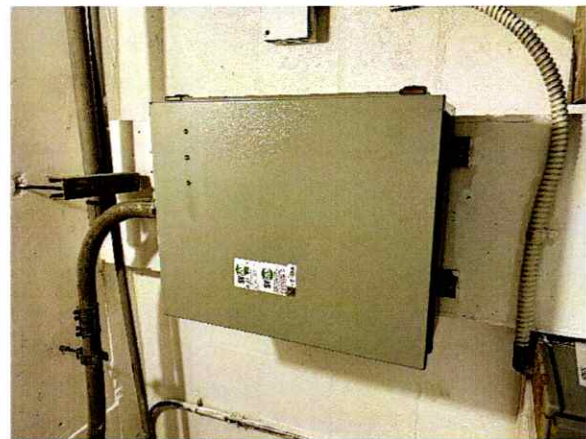
Figure 14: Main Breaker Panel

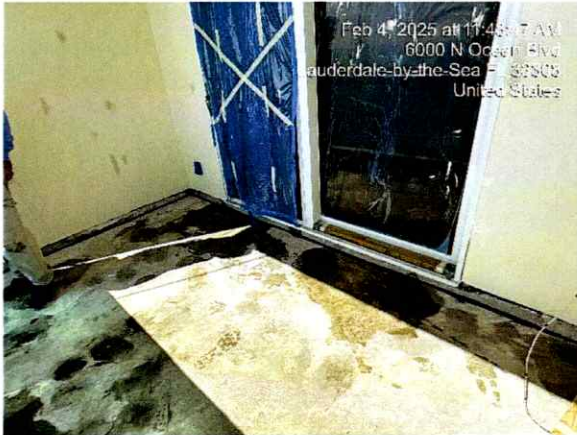
- Component Condition: Good
- Commentary: Starlight Towers is currently under a painting and waterproofing restoration project, scheduled to be completed in June 2025. All exterior paint and waterproofing on balconies will be completed per KEG’s Project Manual and specifications. Guardrail coating was observed in good condition generally. However, it is recommended that regular maintenance protocols are implemented to protect the guardrail system from the environment agents.
- Recommendations: Continuing regular maintenance to all areas addressed.

Figure 15: Balcony After Removal of the Tiling.

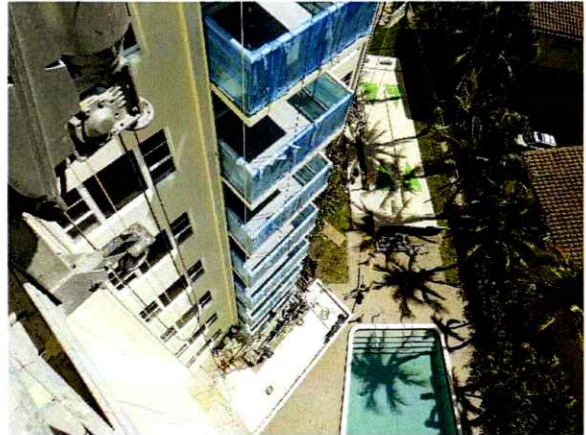
Figure 16: Waterproofing Application in Progress at Balconies.

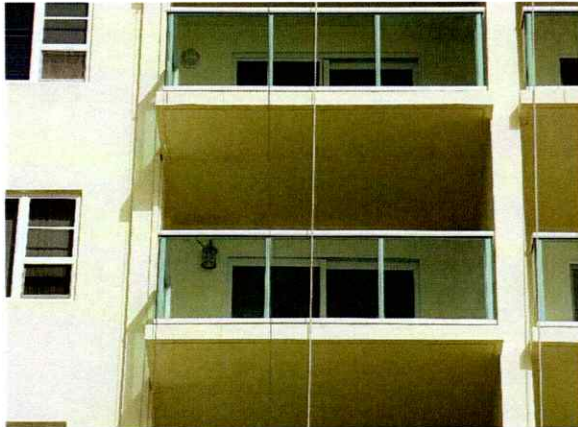
Figure 17: Actual Condition of the Balcony Guardrails

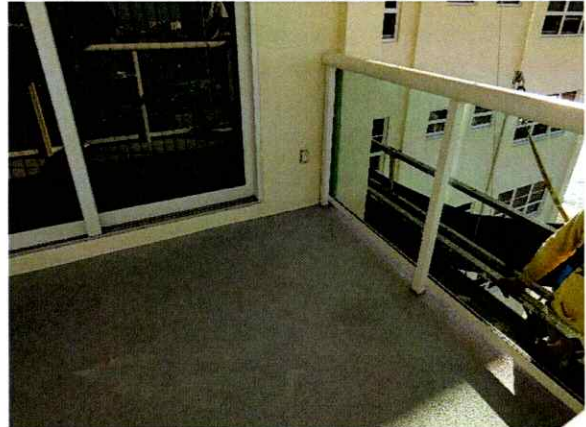
Figure 18: New Waterproofing Installed and Condition of Balcony Railing

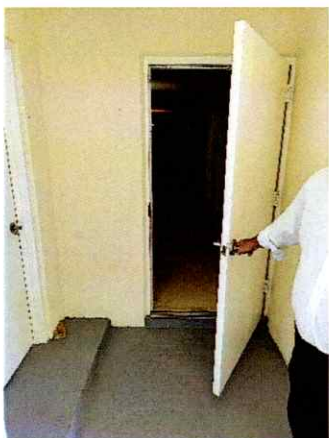
Figure 19: Metal Door for the Staircase.

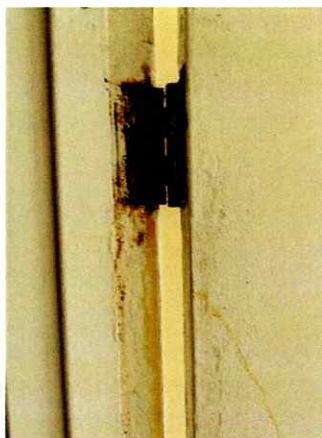
- Component Condition: Good.
- Commentary: Common windows were observed to be in adequate condition and proper operation generally. All fire-rated and non-fire-rated metal doors were observed operating properly. Minor signs of corrosion were observed in some of the metal frames that can be addressed to prolong the useful life of existing doors.
- Recommendations: KEG recommends replacing some of the door hardware and apply proper metal painting protocols and continuing with regular maintenance.

Figure 20: Signs of Corrosion at Metal Door Frame.

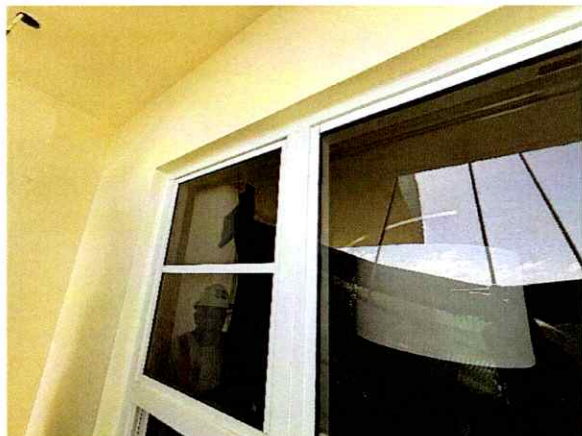
Figure 21: Sealant Was Observed in Good Condition.

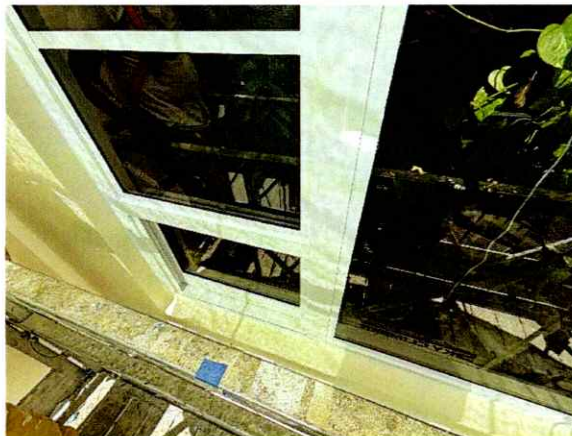
Figure 22: Sealant Was Observed in Good Condition.

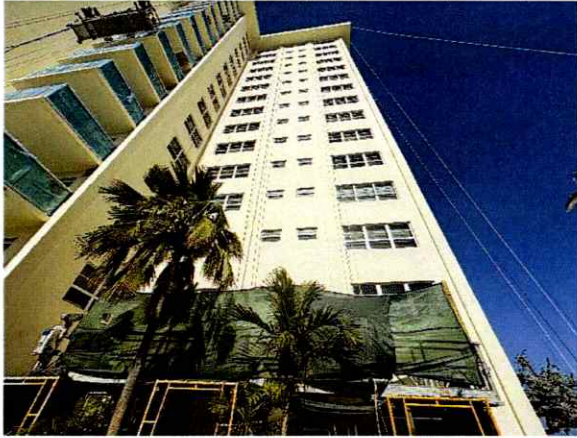
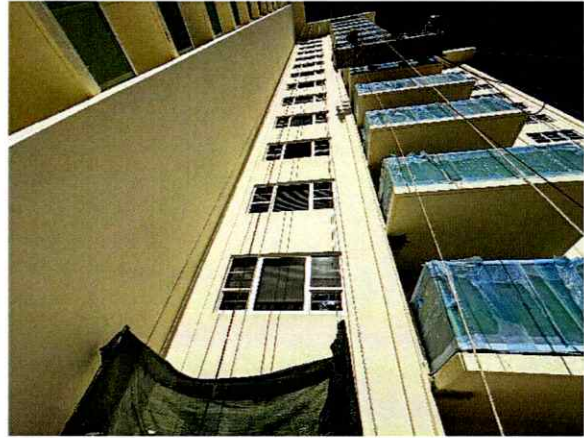
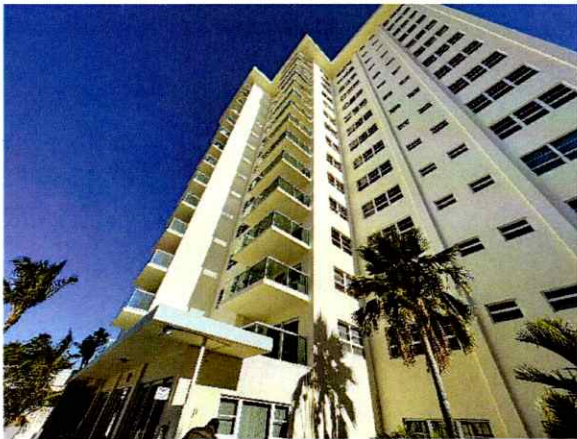
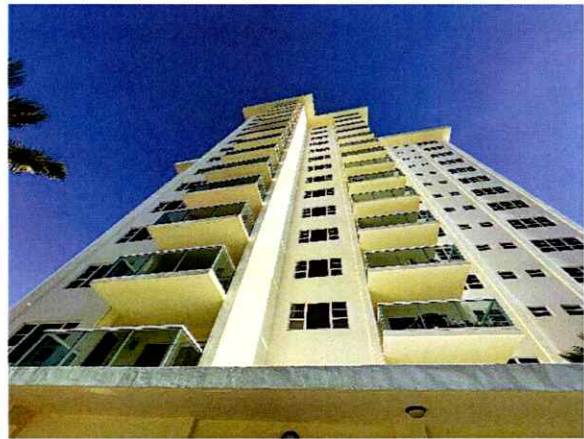
- Component Condition: Good.
- Commentary: Part of the concrete restoration project includes addressing exterior cementitious finish of the building envelope after the concrete repair completion.
- Recommendations: Regular maintenance after exceeding useful life to prolong the longevity of the structure.

Figure 23: Condition of the Façade After Repairs

Figure 24: Condition of the Façade After Repairs

Figure 25: Condition of the Façade After Repairs

Figure 26: Condition of the Façade After Repairs
